TMI-2 CORE HORSESHOE RING EXAMINATIONS

Published October 1987

**EG&G Idaho, Inc.
Idaho Falls, Idaho 83415**

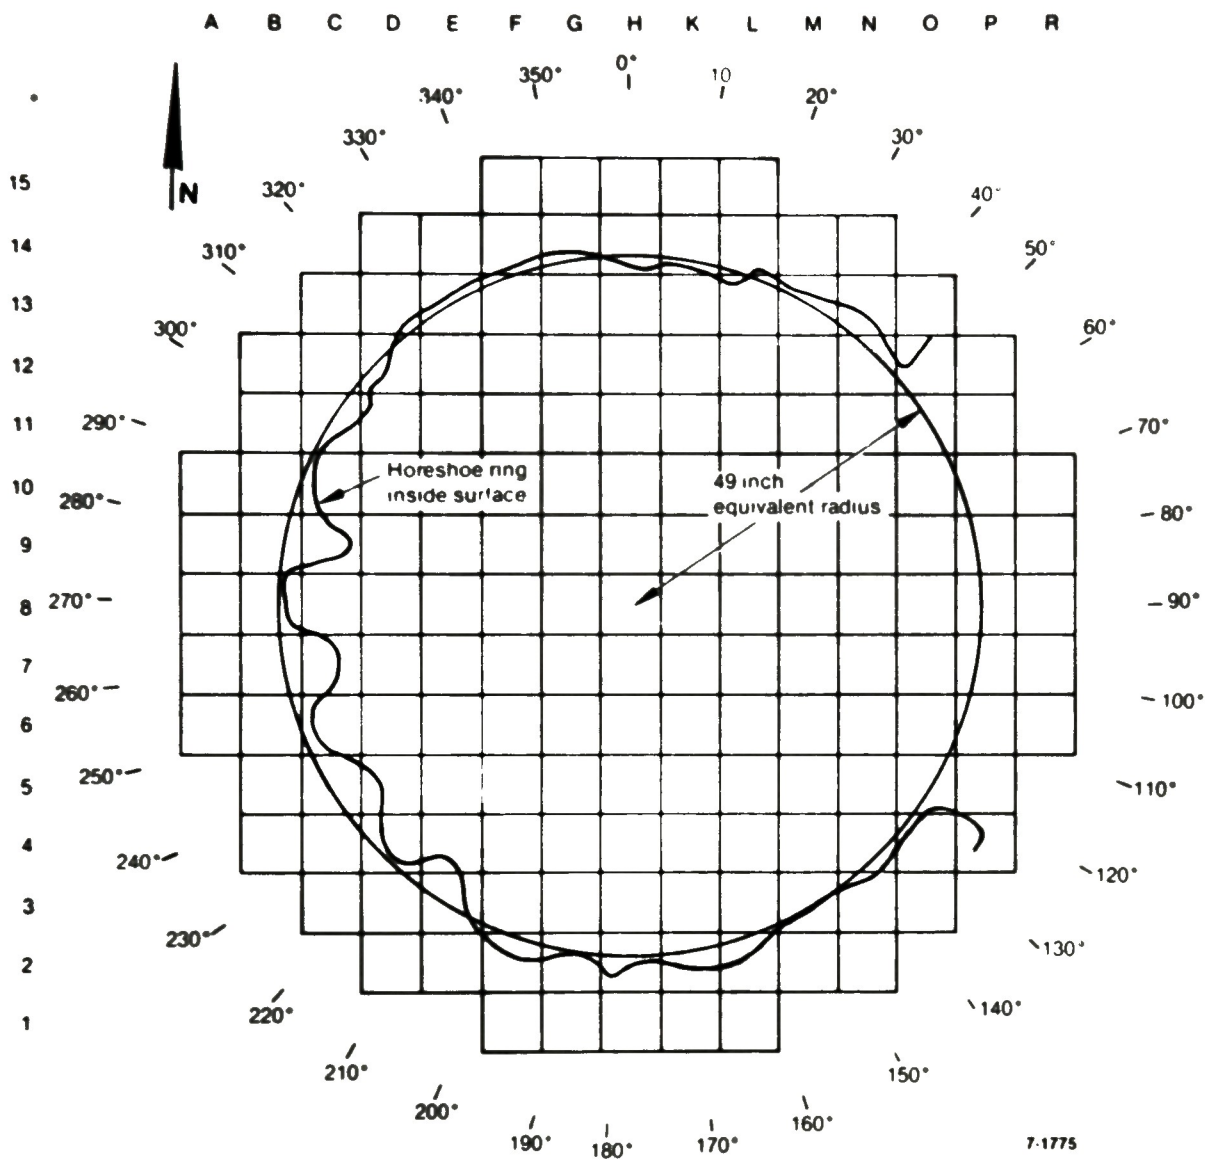
Figure 2. Estimated radial configuration of horseshoe-shaped ring of agglomerate core material.

1. In June, a horseshoe-shaped ring of fused-together core material was observed. It projected inwards from standing rod bundles from 120° to 50° azimuth as shown in Fig. 2. The average inward projection of the ring is estimated to be 49 inches from the core centerline. In several locations, the visible bottom edge of the ring receded, creating a cave-like geometry (see Plates A-2, A-4, A-5, and A-7).

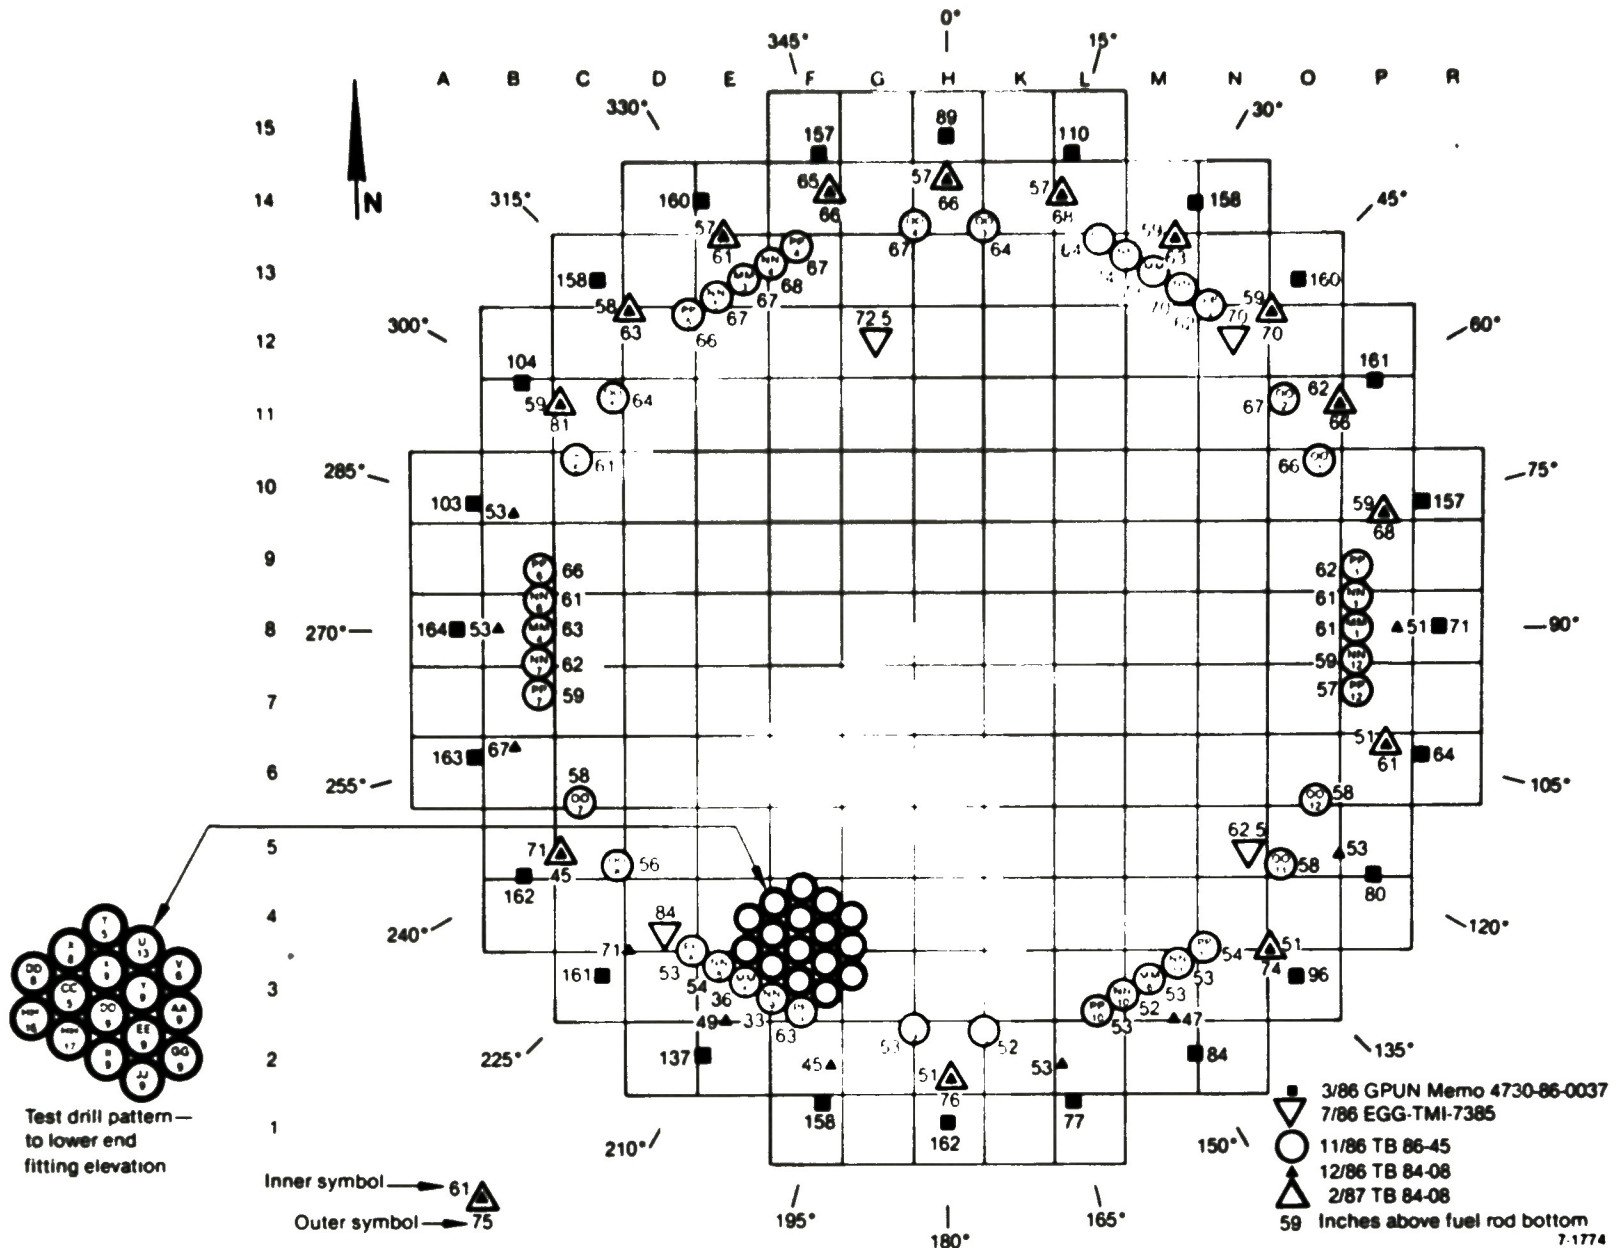
Figure 3. Hard-stop locations from mechanical probing measurements.

1. The July core boring at core position D4 where the hard-crust was first contacted near 84 inches above the fuel rod bottoms.

2. The March 1986 probing data at core positions B10, B11, H15, L1, M2, O3, and P5 that indicate a hard stop at 110 to 77 inches above the fuel rod bottom, which is consistent with some of the video survey data both in elevations and irregularity of the ring upper surface contour.

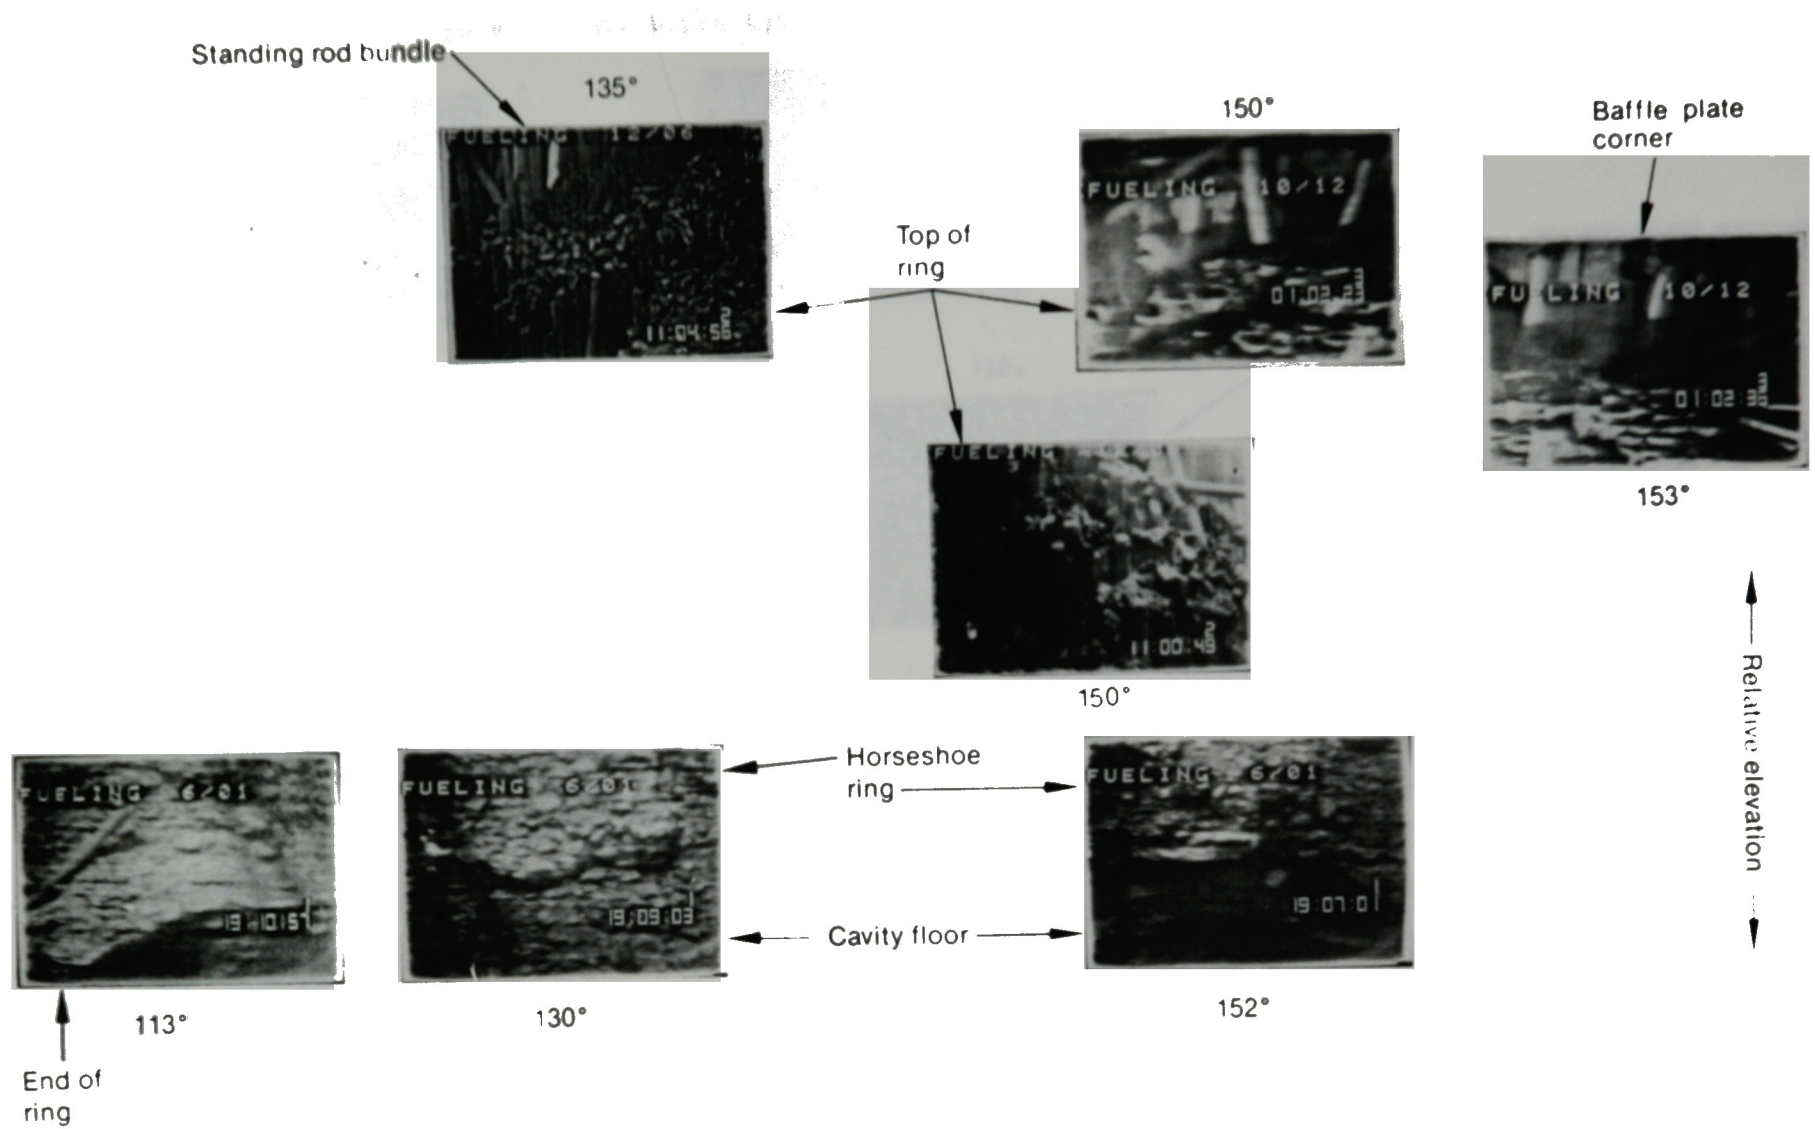
Plate A-1. Horseshoe ring between 110° and 155° azimuth (Southeast).

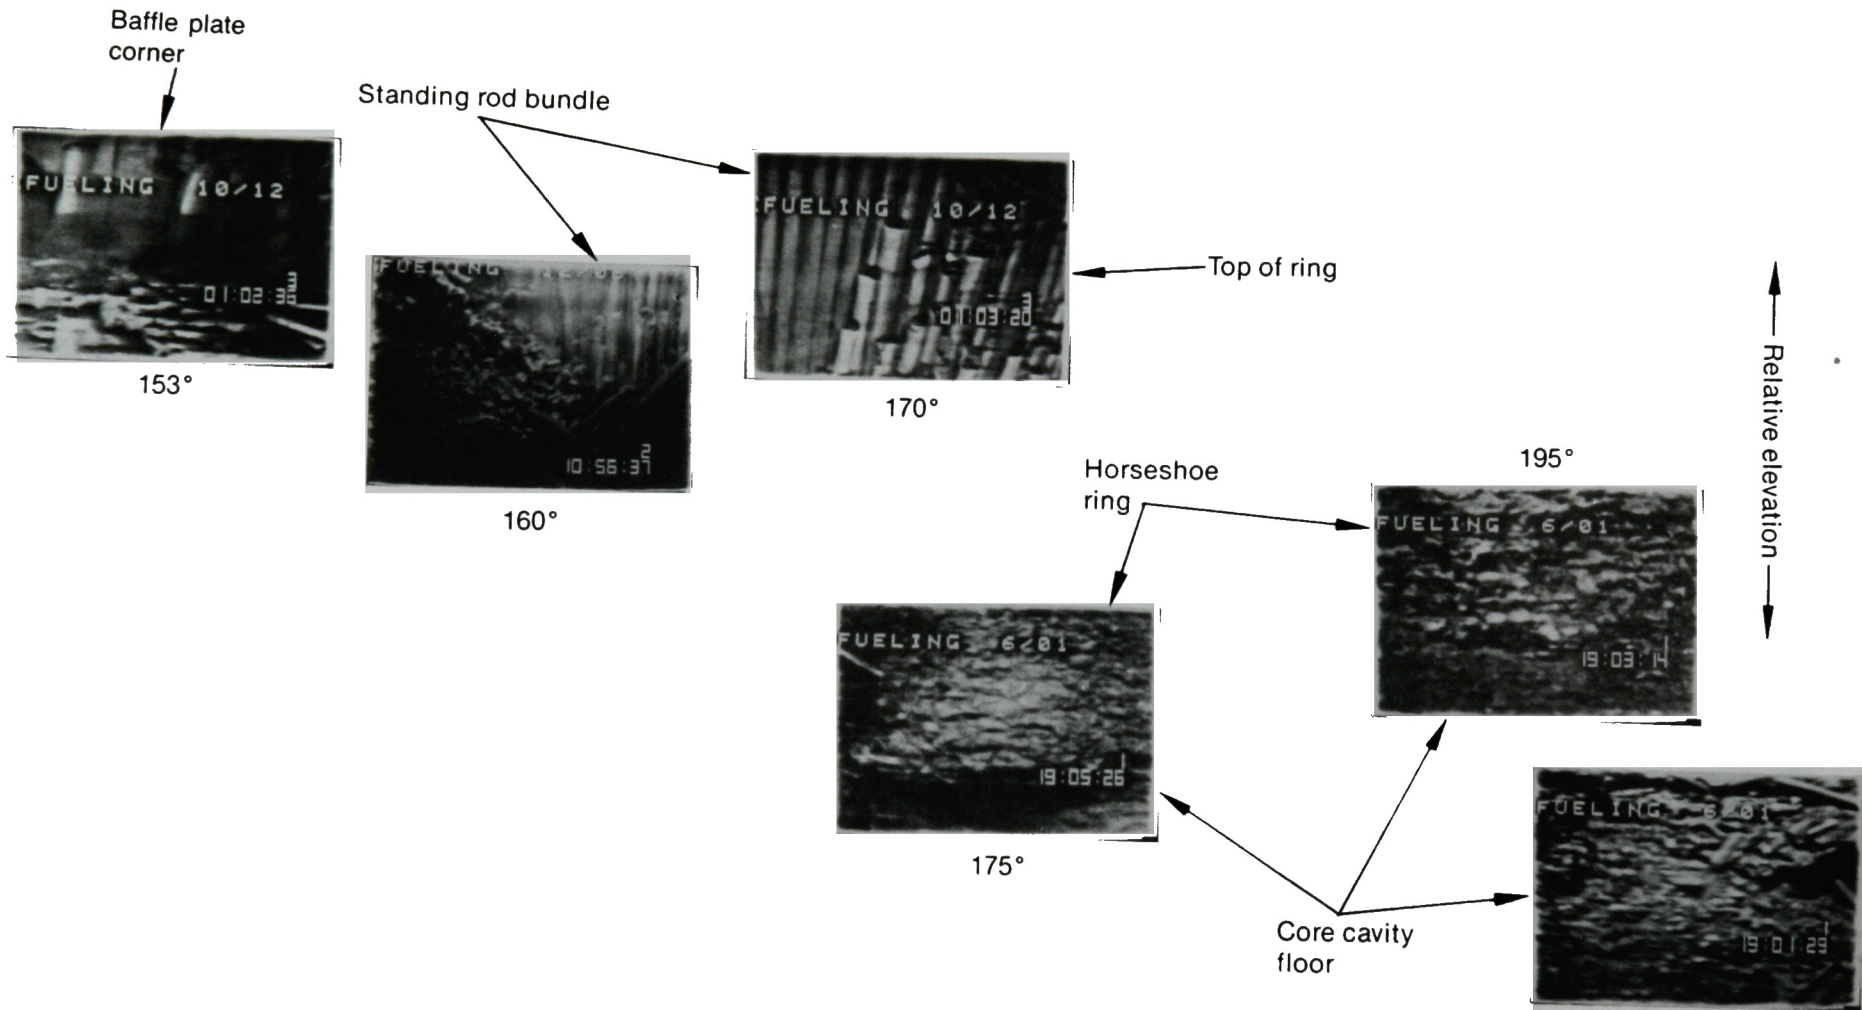
Plate A-2. Horseshoe ring between 153° and 200° azimuth (South).

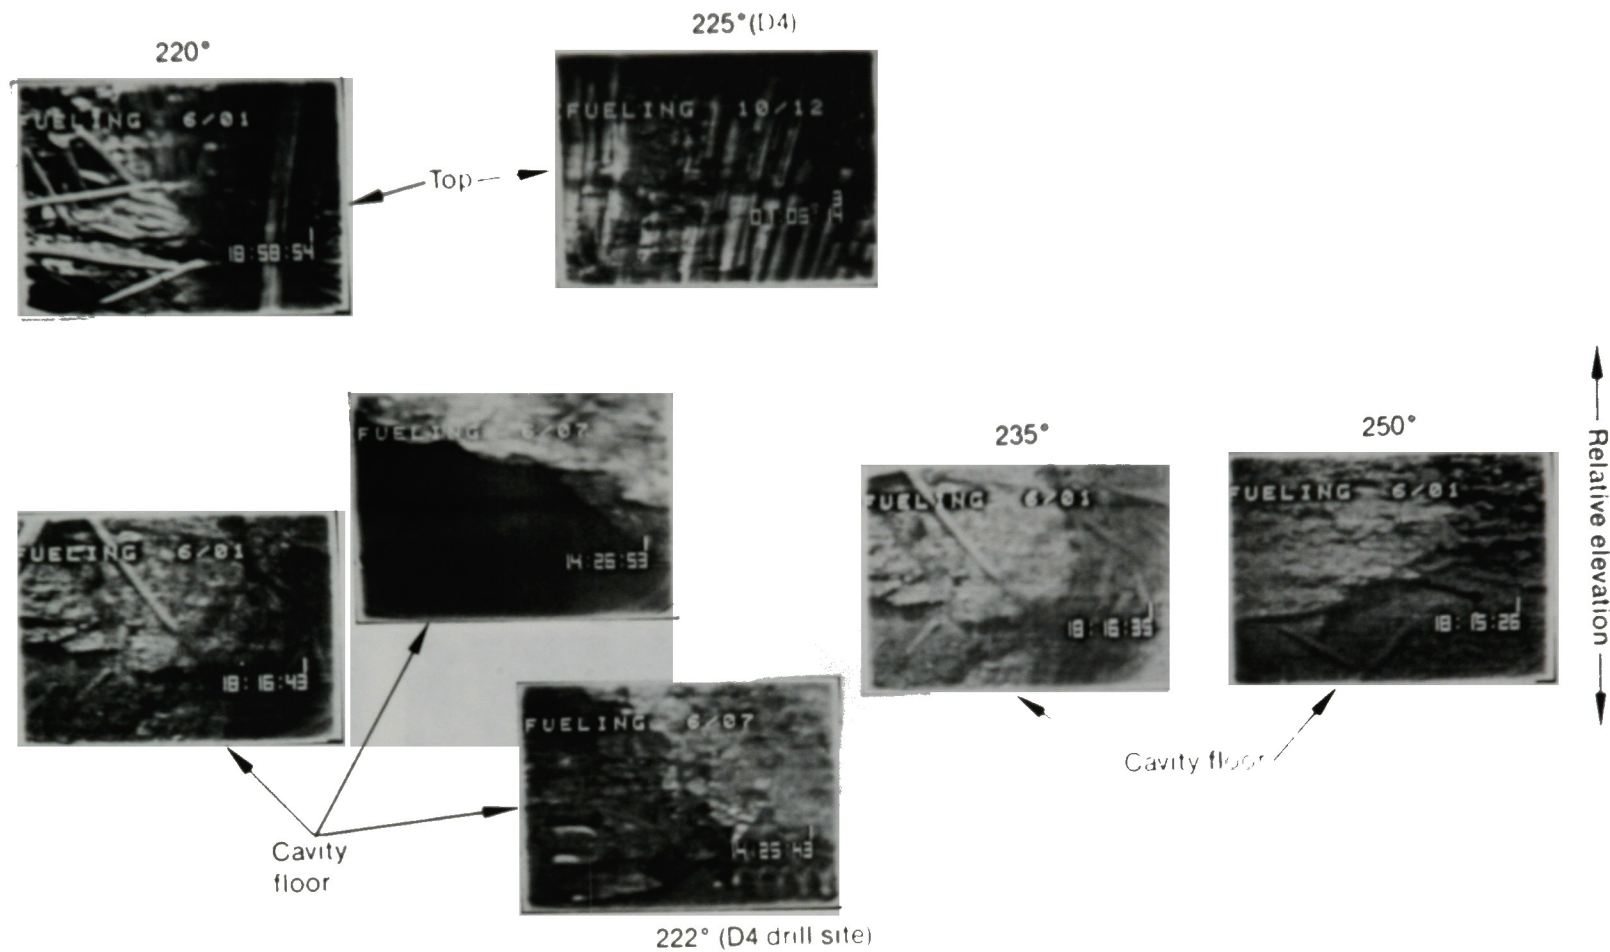
Plate A-3. Horseshoe ring between 200° and 250° azimuth (Southwest).

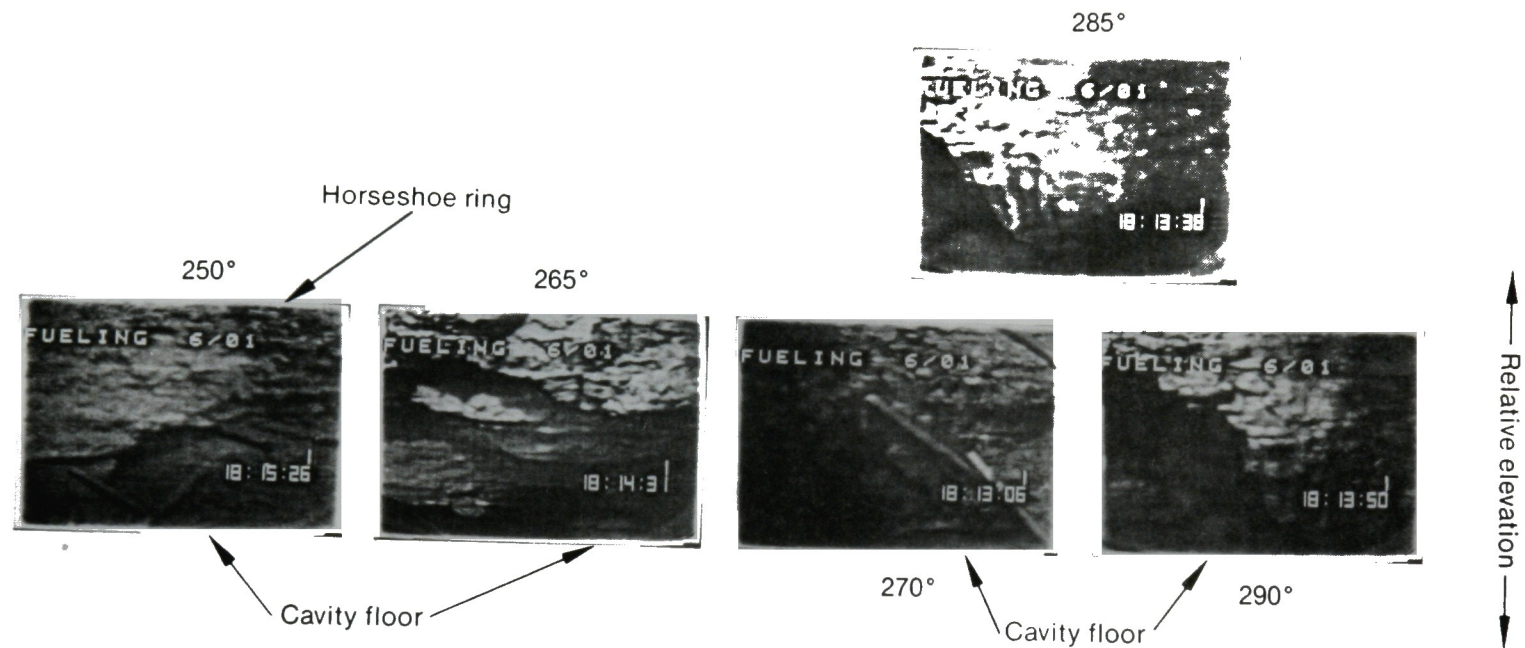
Plate A-4. Horseshoe ring between 250° and 290° azimuth (West).

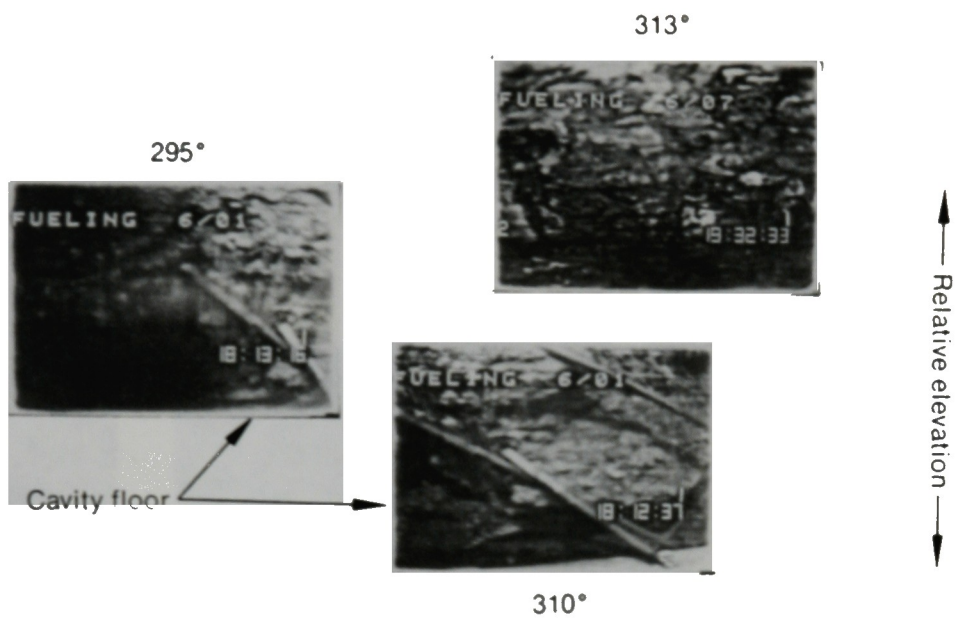
Plate A-5. Horseshoe ring between 290° and 335° azimuth (Northwest).

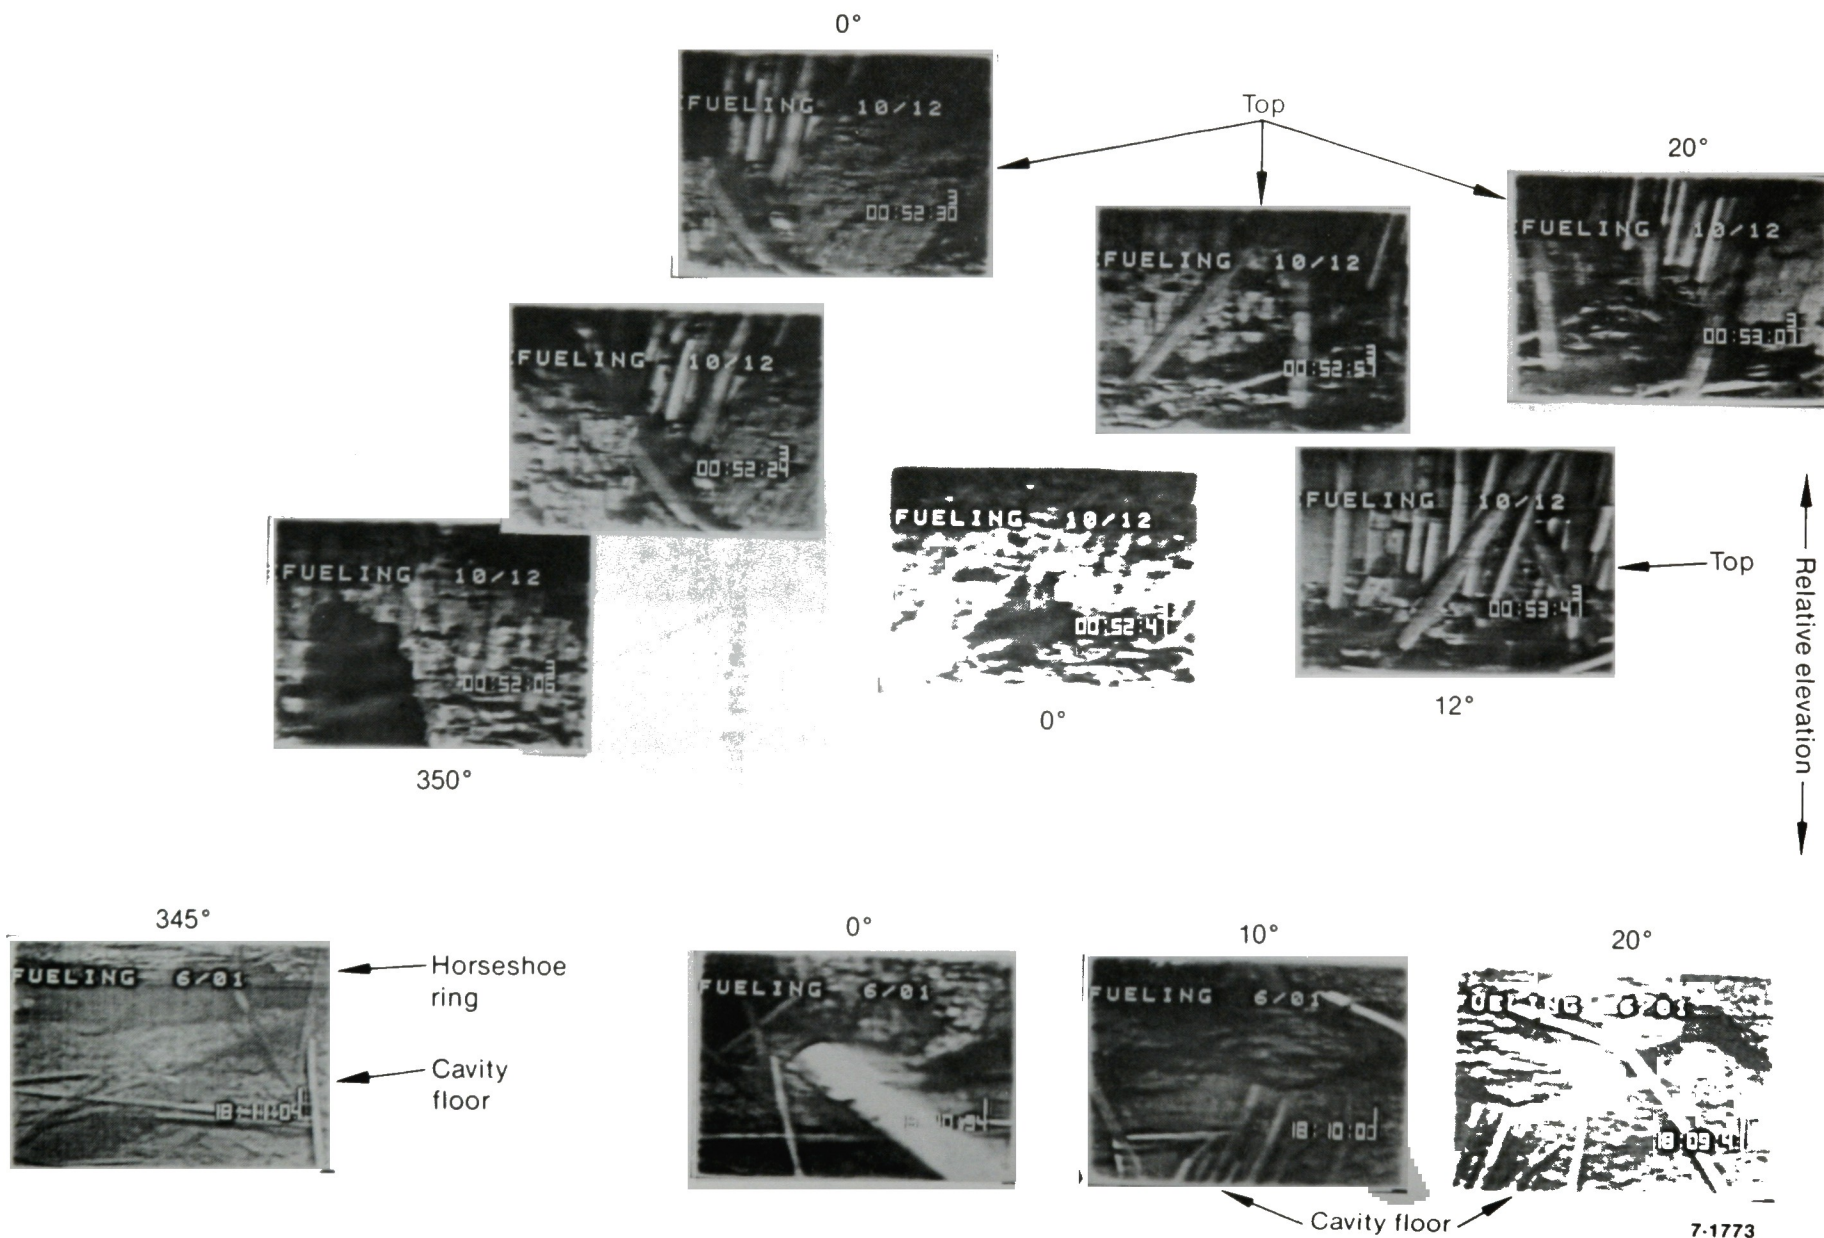
Plate A-6A. Horseshoe ring between 335° and 25° azimuth (North) before (06/01) and after (10/12) core boring.

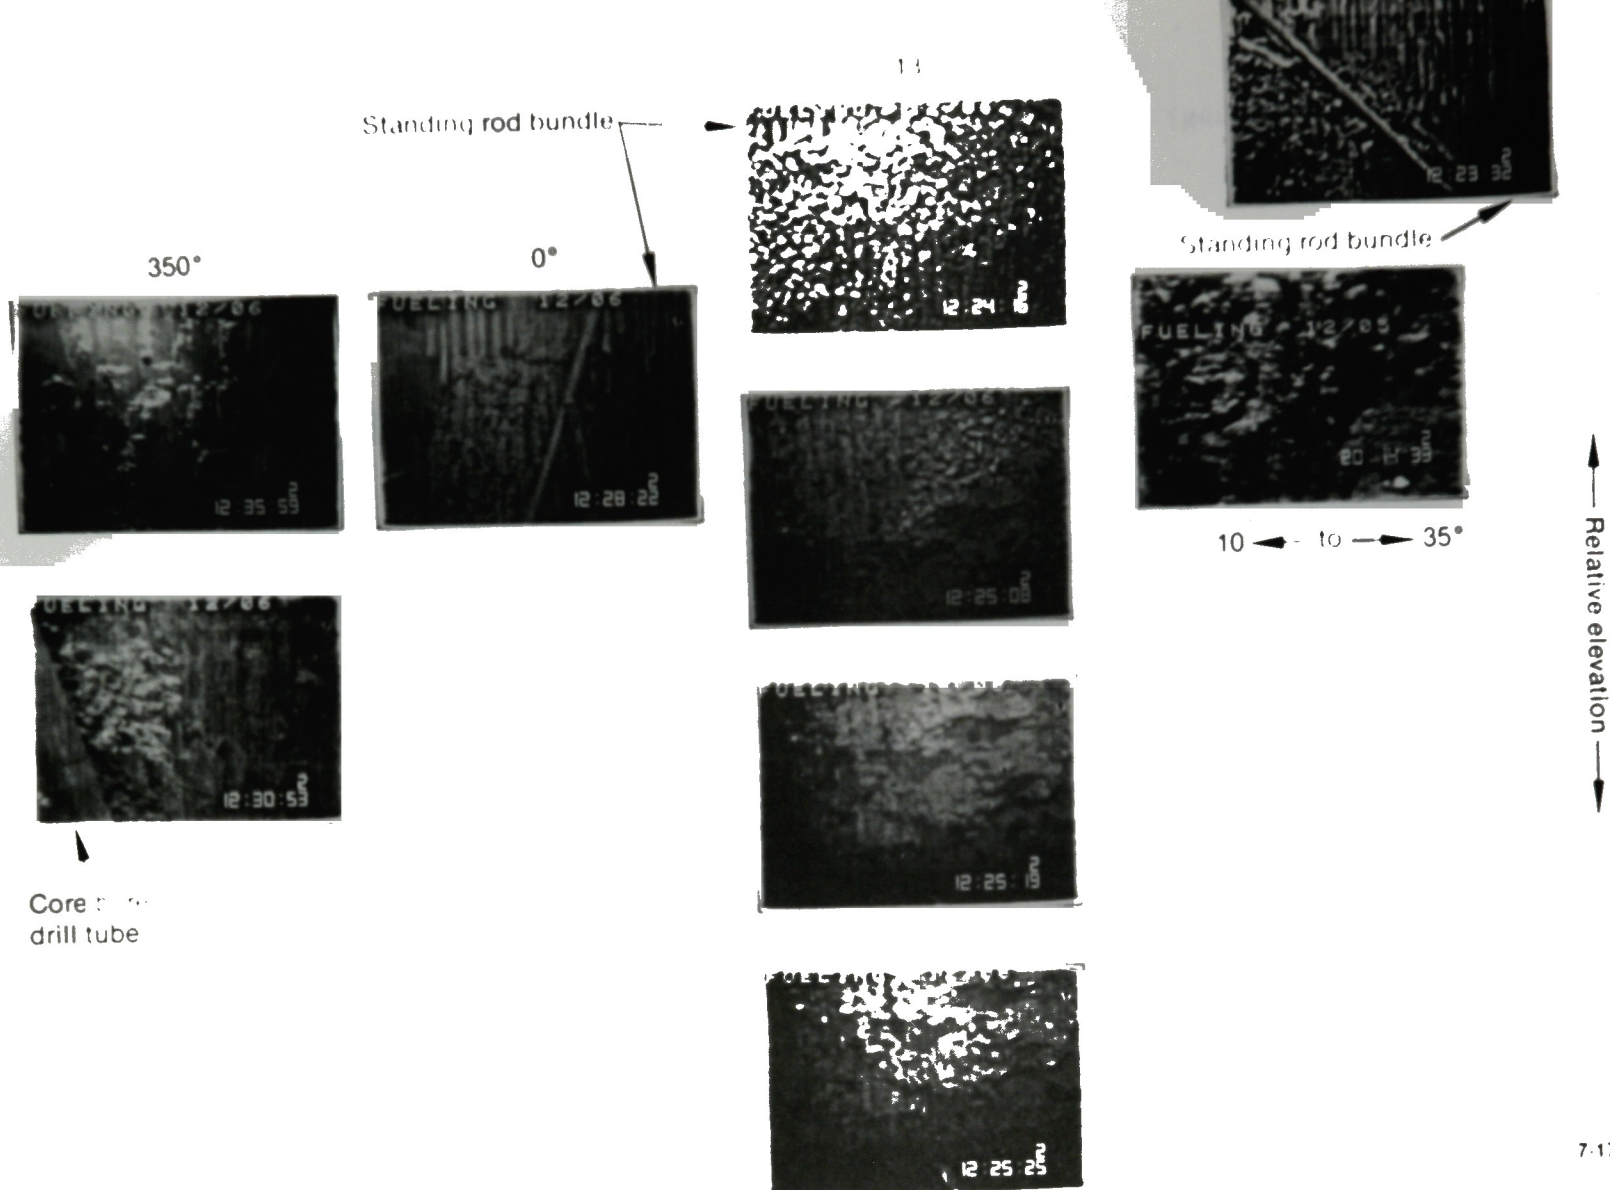
Plate A-6B. Horseshoe ring between 335° and 25° azimuth (North) after overlapping hole drilling.

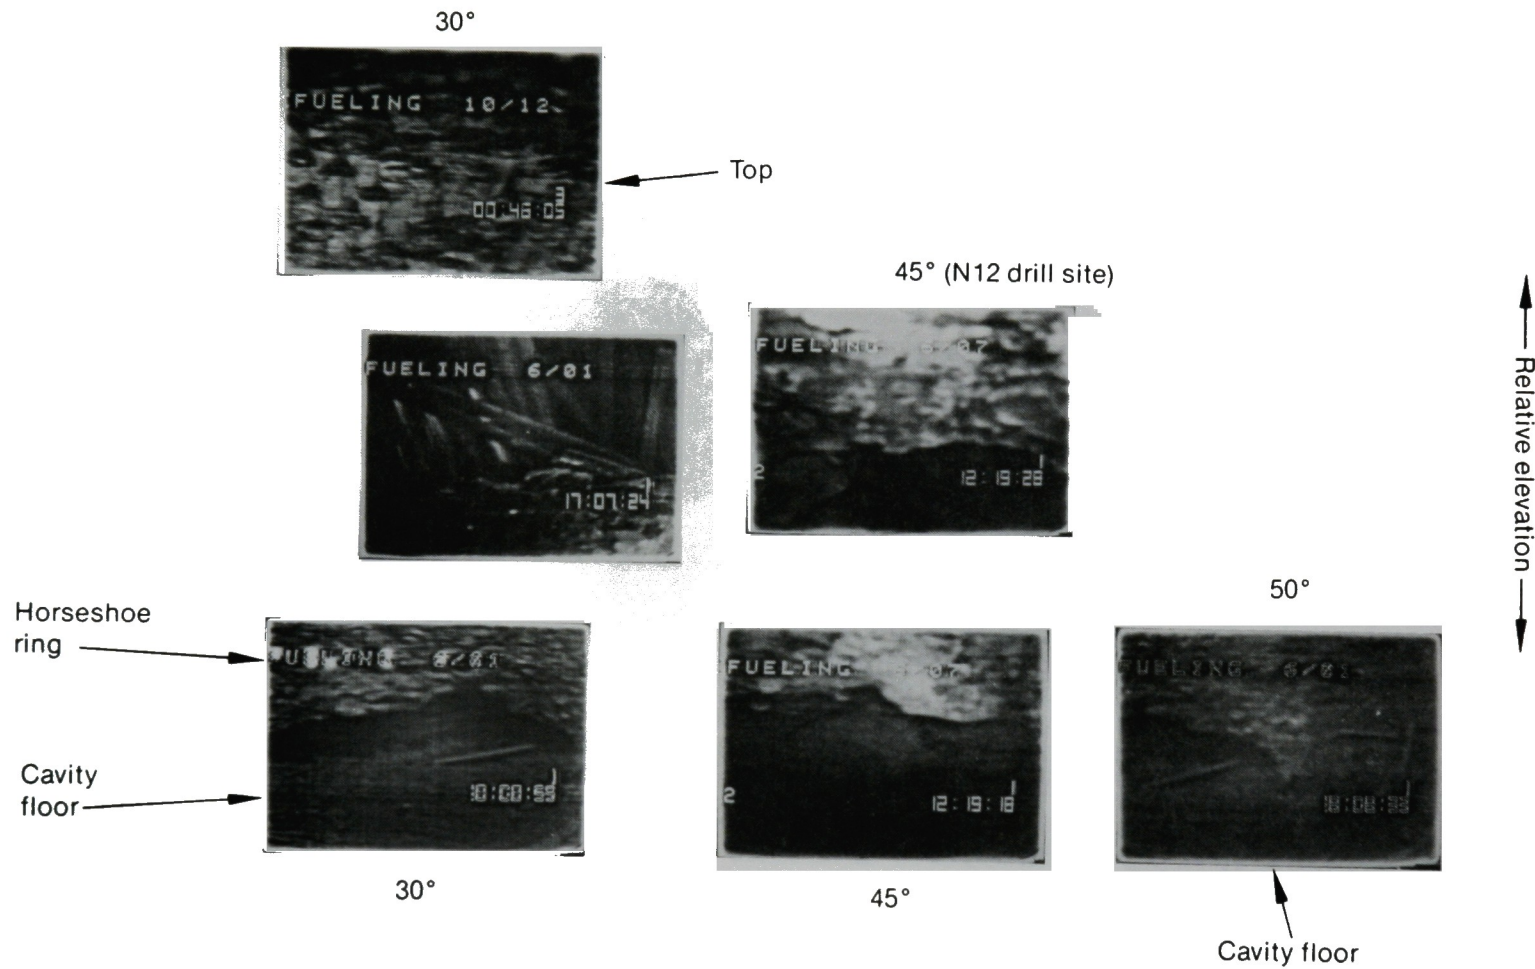
Plate A-7. Horseshoe ring between 25° and 70° azimuth (Northeast).

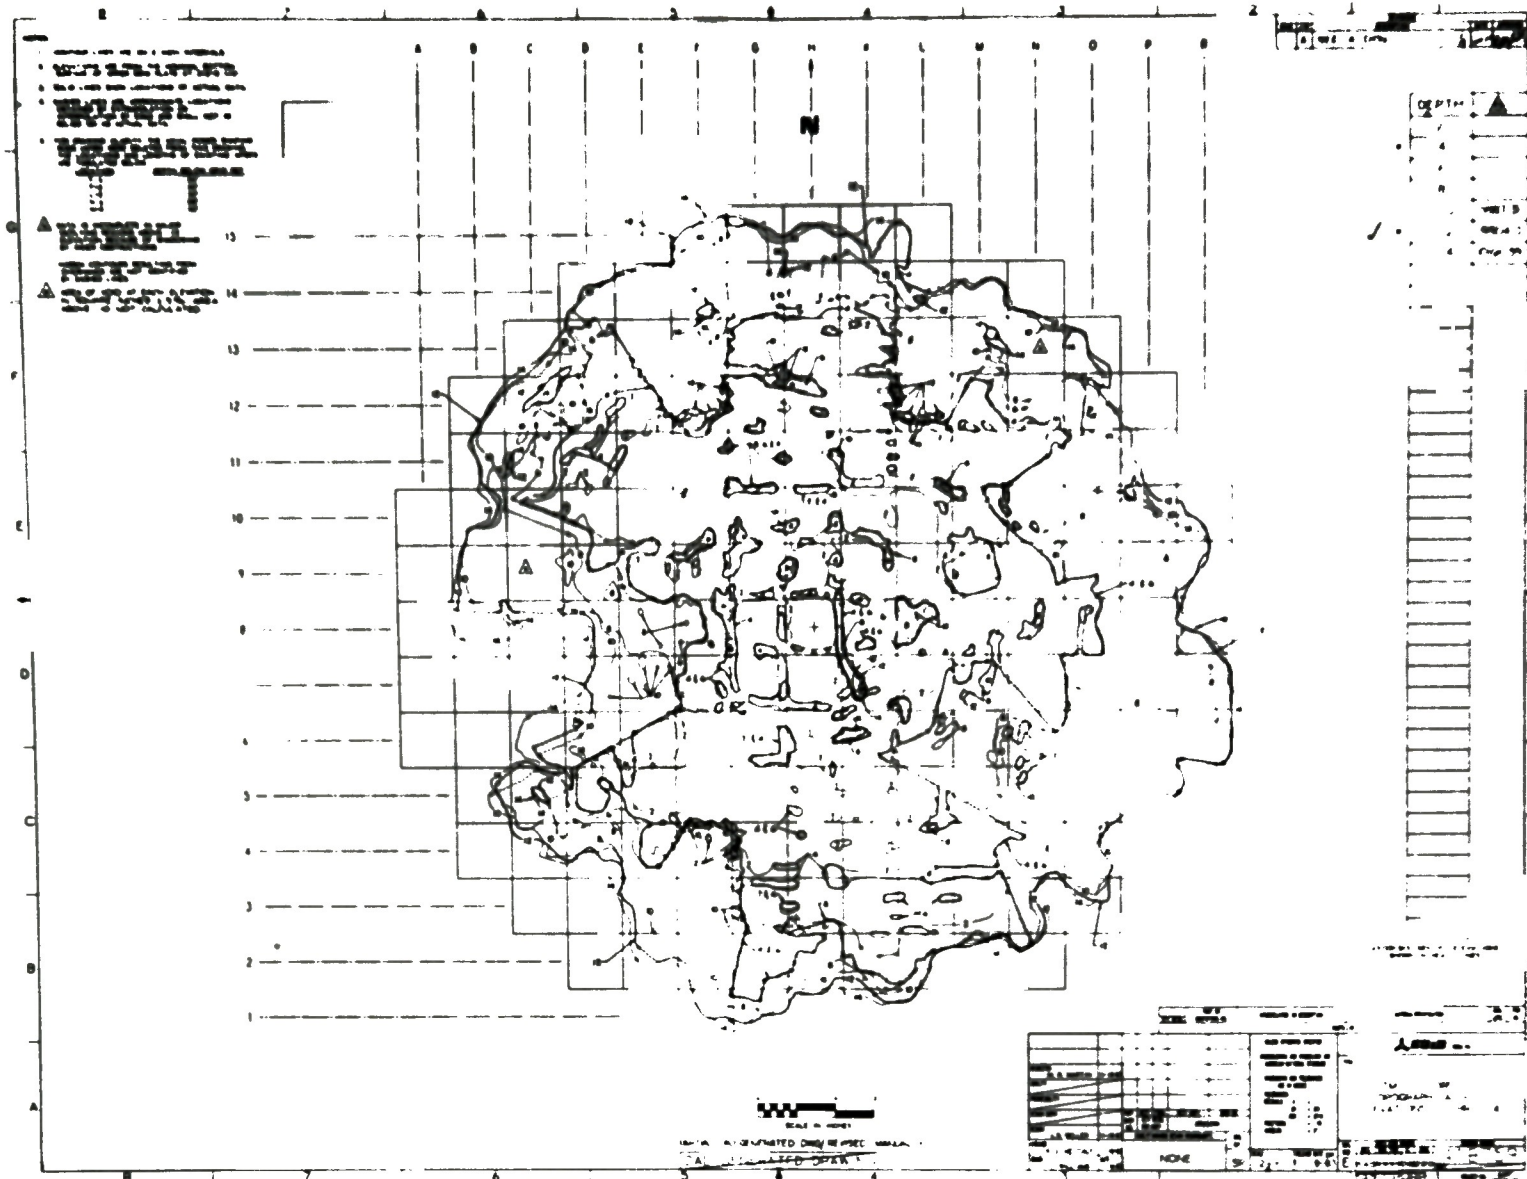
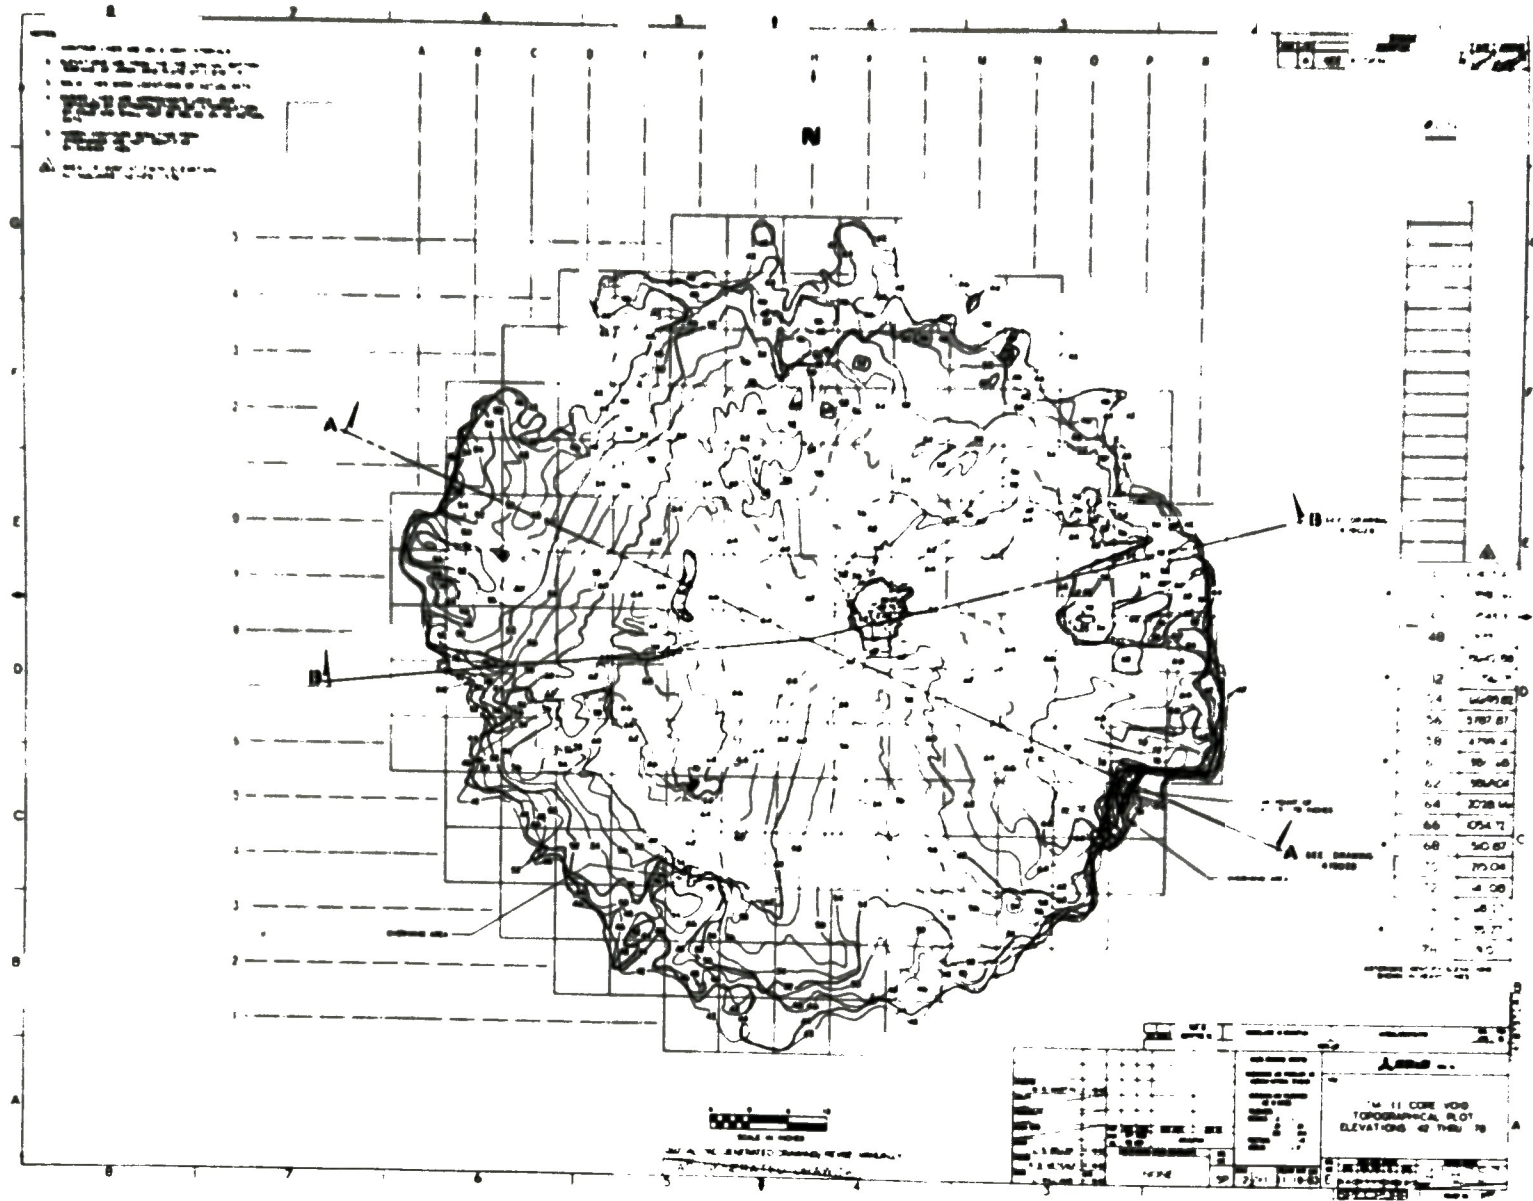
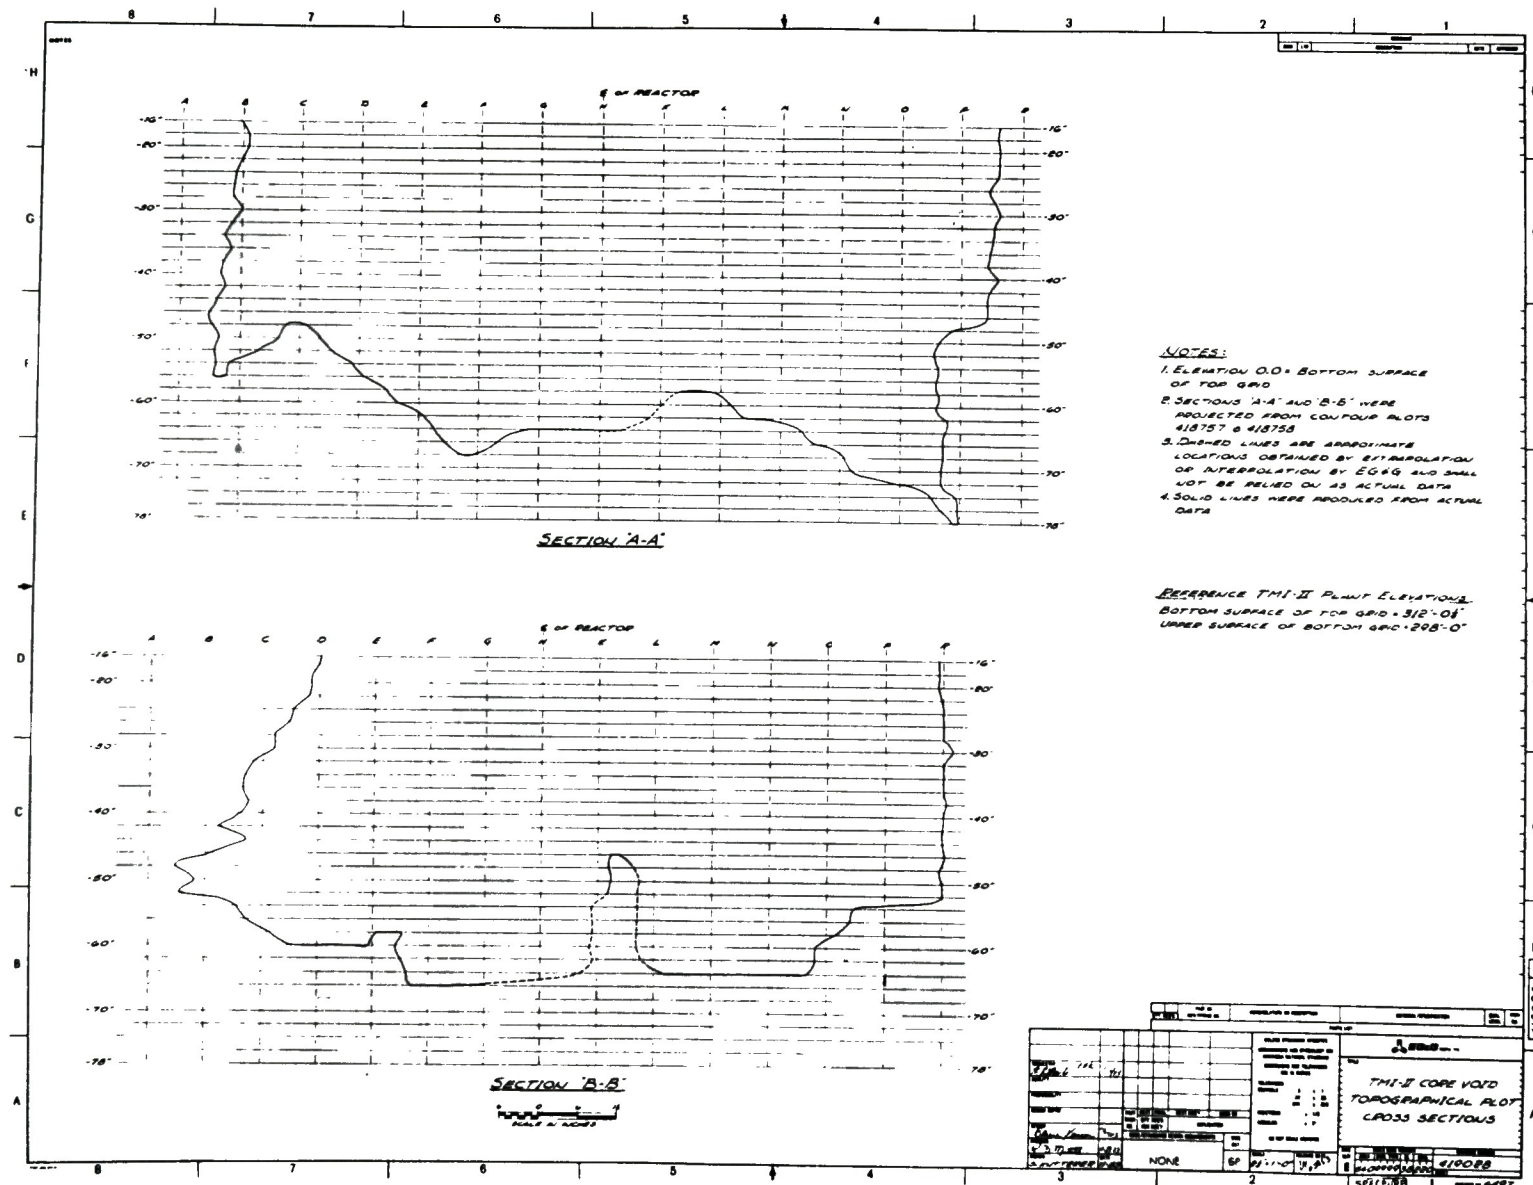
On August 31, 1983, an ultrasonic scanner survey was made to determine the shape and dimensions of the core cavity. Figures B-6 through B-9 are the resulting topographical maps of the core cavity. The core topographical features included the following:

- The cavity extended from the bottom of the upper grid-plate downward to approximately 7.5 ft above the core bottom and radially to the core baffle plates in some places

- The core cavity volume was equivalent to approximately 26% of the original core region
- Fuel assembly remnants appeared to almost completely encircle the core cavity toward the upper grid plate; the maximum fuel assembly damage appeared to be on the core East side, and the least fuel assembly damage on the core West side
- The ASPRs that had been inserted earlier projected from the cavity ceiling and interfered with ultrasonic-scanner measurement of topography in the cavity upper regions.
